SIGNIA[™] STAPLING SYSTEM

Troubleshooting Guide

This guide is intended for Medtronic sales force. It will help you to troubleshoot situations that the Signia[™] stapling system may encounter.

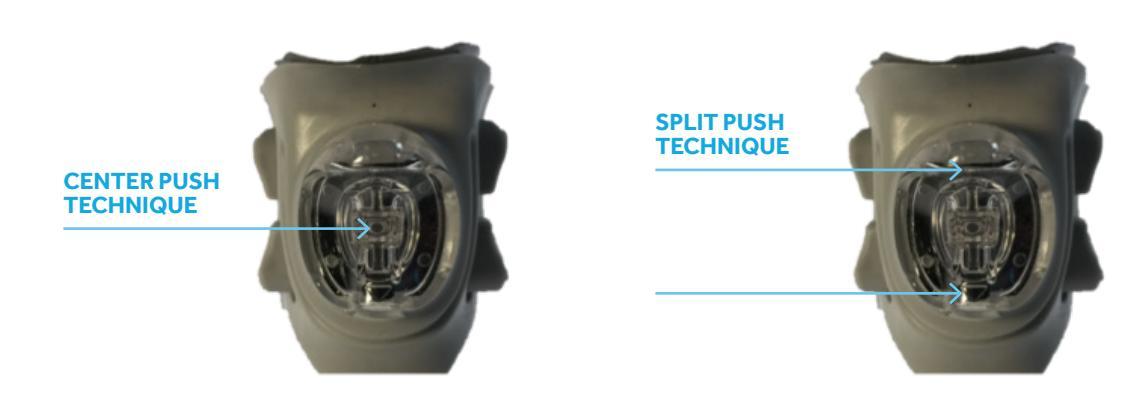
Articulation Push — Attempt techniques shown below. The user may use whichever works best for them. Users may press sideways on the toggle in the indicated areas to rock or seesaw the toggle.

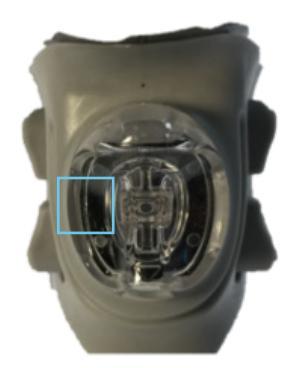
Articulation Pull — Use one finger to pull inward on the desired button. This will rock the toggle and activate the internal button.

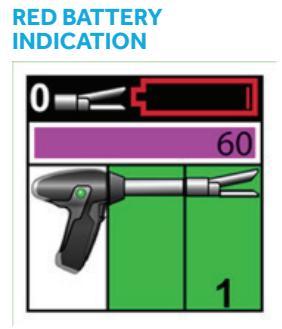
GRAPHIC BATTERY LEVEL

Yellow indication

- 9.1.1. All functions available. Indicates low remaining capacity.
- 9.1.2. Two complete firings remain.

Red indication

9.2.1. Insufficient battery. Firing is disabled until the system is charged.

Place the Signia[™] power handle into a charger. Allow the unit to charge for at least three hours or until the charging status LED displays a solid green light.

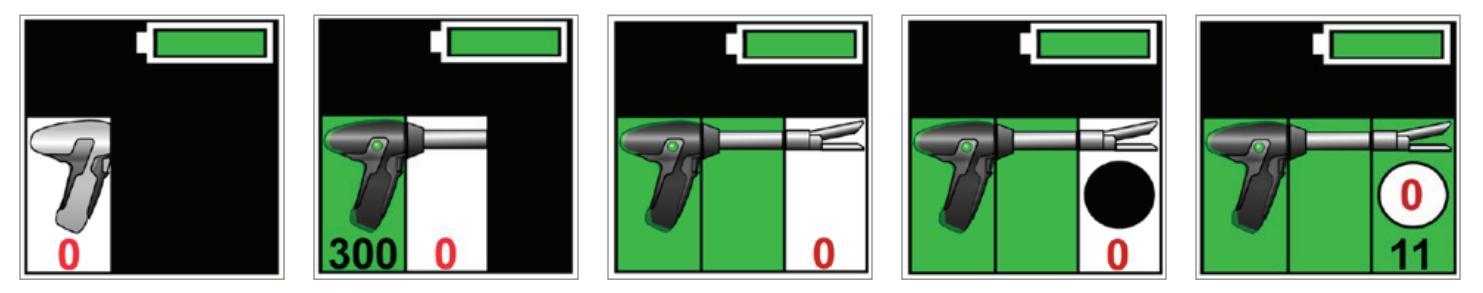
GRAPHIC USAGE COUNTERS

A segment of the system is displaying a zero uses counter.

This graphic indicated that the attached power shell has no remaining uses. The power shell should be discarded and a new power shell should be attached.

This screen can indicate the normal end of life for a Signia[™] linear adapter after all uses have been consumed.
